# Michael Callahan(RS) Associates, LLC.

High Rise Sample I

AnyCity, AnyState  
Account Sample - Version 1  
January 1, 2019

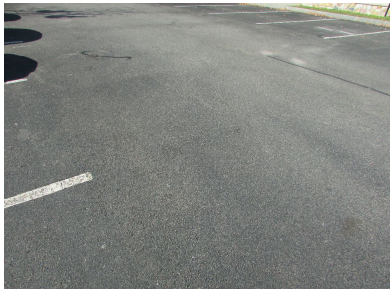
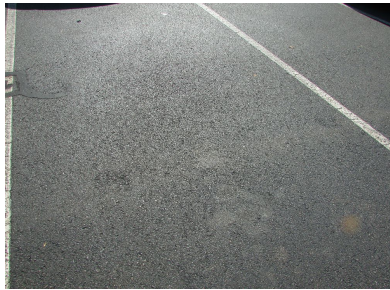
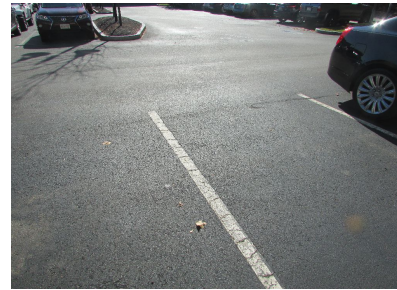
### Asphalt Overlay - Replacement - 2023

50,600 - sq.ft. of asphalt overlay (big parking lot) @ \$4.75 = \$240,350.00  
 8,300 - sq.ft. of asphalt overlay (small parking lot) @ 4.75 = 39,425.00  
 Total = \$279,775.00

A good maintenance cycle along with 'as-needed' repairs and/or replacement to the asphalt overlay will help the overlay to last the estimated 20-30 year Useful Life. In most cases repairs and/or replacements to areas of the asphalt overlay will not increase the overall Useful Life of the asphalt overlay.

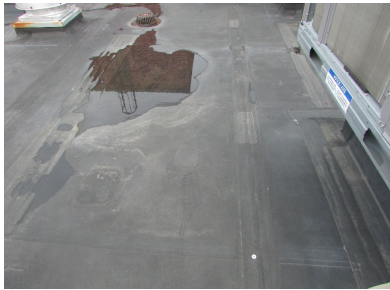
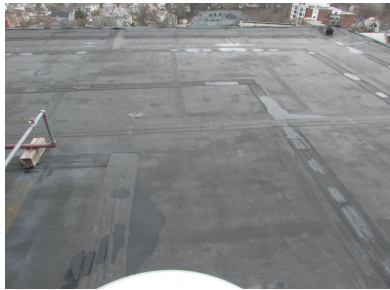
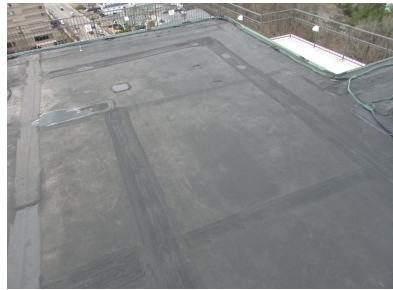
3,600 - sq.ft. of roofing area @ \$28.00 = \$100,800.00  
Total = \$100,800.00

Typically, flat rubber membrane roofs come with a 20yr. Limited Warranty.

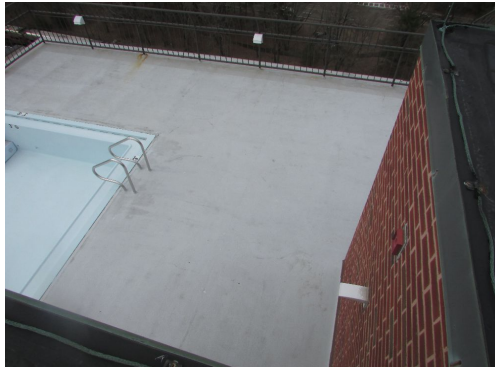
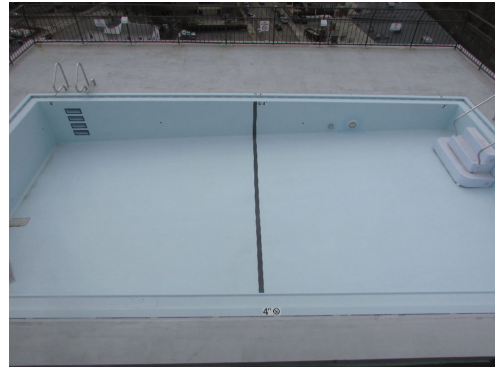
*Roof - Pool Deck Area continued...*

2,935 - sq.ft. of topcoat

@ \$14.00 = \$41,090.00  
Total = \$41,090.00

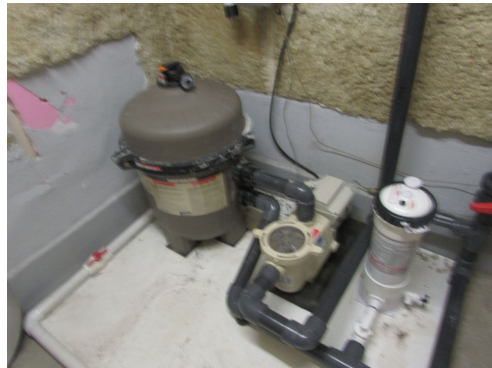
## **Pool - Filter - 2028**

Asset ID	1170	1 Total Asset Cost	@ \$4,800.00
		Percent Replacement	100%
Placed in Service	Recreation/Pool	Future Cost	\$5,736.44
Useful Life	January 2016	Assigned Reserves	<i>none</i>
Replacement Year	12	Annual Assessment	\$289.58
Remaining Life	2028	Interest Contribution	<u>\$2.03</u>
	9	Reserve Allocation	\$291.61

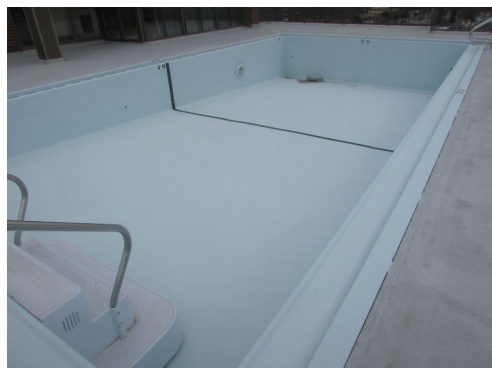
## **Pool - Replacement (Aluminium Tub) - 2025**

The pool is located on the roof of the building. The pool is a aluminium tub style pool. The

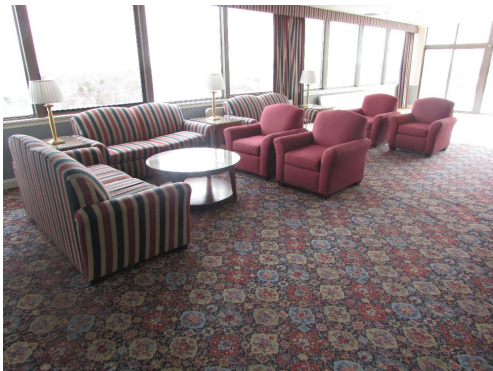
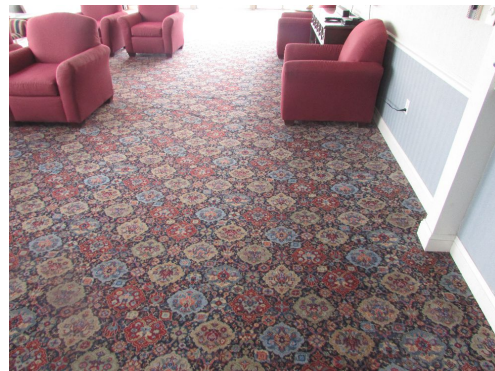
### Community Room - Renovations - 2020

Asset ID	1174	1 Total	@ \$100,000.00
		Asset Cost	\$100,000.00
		Percent Replacement	100%
Interior Furnishings		Future Cost	\$102,000.00
Placed in Service	January 2006	Assigned Reserves	\$87,403.28
Useful Life	14		
Replacement Year	2020	Annual Assessment	\$6,534.58
Remaining Life	1	Interest Contribution	<u>\$657.56</u>
		Reserve Allocation	\$7,192.14

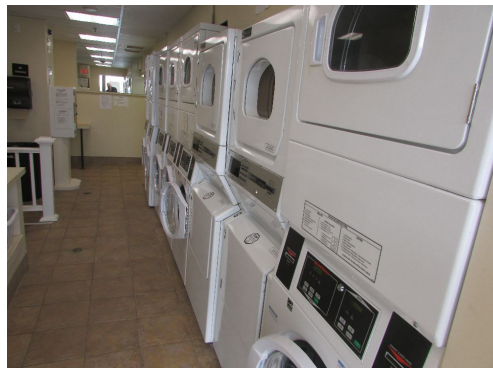
### **Laundry Room - Renovations - 2026**

Asset ID	1173	1 Total	@ \$50,000.00
		Asset Cost	\$50,000.00
		Percent Replacement	100%
		Future Cost	\$57,434.28
		Assigned Reserves	<i>none</i>
Placed in Service	January 2006	Annual Assessment	\$3,754.06
Useful Life	20	Interest Contribution	<u>\$26.28</u>
Replacement Year	2026	Reserve Allocation	\$3,780.33
Remaining Life	7

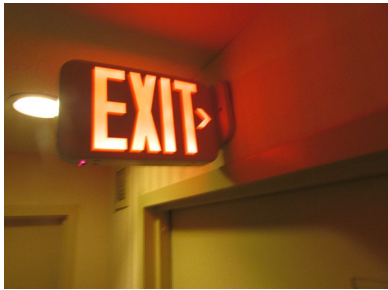
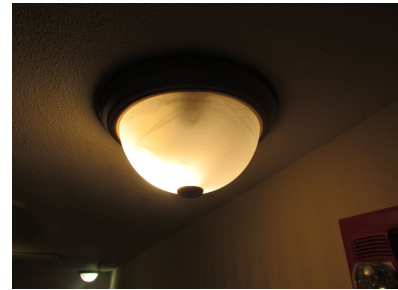
### Lighting - Interior (Hallway) - 2024

Asset ID	1009	1 Total	@ \$38,740.00
		Asset Cost	\$38,740.00
		Percent Replacement	100%
		Future Cost	\$42,772.09
		Assigned Reserves	<i>none</i>
Placed in Service	Interior Furnishings January 1982	Annual Assessment	\$3,941.56
Useful Life	30	Interest Contribution	<u>\$27.59</u>
Adjustment	12	Reserve Allocation	\$3,969.16
Replacement Year	2024		
Remaining Life	5

44 - ceiling fixtures	@	\$185.00 =	\$8,140.00
120 - recessed light fixtures	@	210.00 =	25,200.00
24 - EXIT signs	@	225.00 =	5,400.00
		Total =	\$38,740.00

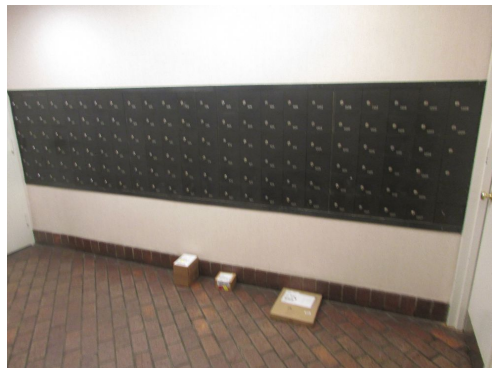
### Mailbox - Replacements - 2029

Asset ID	1133	1 Total	@ \$16,500.00
		Asset Cost	\$16,500.00
		Percent Replacement	100%
		Future Cost	\$20,113.41
		Assigned Reserves	<i>none</i>
Placed in Service	Interior Furnishings		
	January 1982		
Useful Life	30		
Adjustment	17	Annual Assessment	\$910.59
Replacement Year	2029	Interest Contribution	<u>\$6.37</u>
Remaining Life	10	Reserve Allocation	\$916.97

5 - sets of 30 mailboxes (wall clusters) @ \$3,300.00 = \$16,500.00  
Total = \$16,500.00

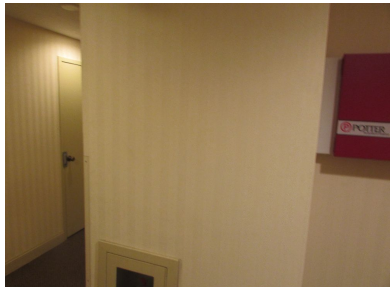
### Wall Covering - Wallpaper - 2019

Asset ID	1185	1 Total	@ \$190,800.00
		Asset Cost	\$190,800.00
		Percent Replacement	100%
	Interior Furnishings	Future Cost	\$190,800.00
Placed in Service	January 1982	Assigned Reserves	\$190,800.00
Useful Life	30		
Replacement Year	2019	Annual Assessment	\$4,856.26
Remaining Life	0	Interest Contribution	<u>\$33.99</u>
		Reserve Allocation	\$4,890.25

21,200 - sq.ft. of wallpaper @ \$9.00 = \$190,800.00  
Total = \$190,800.00

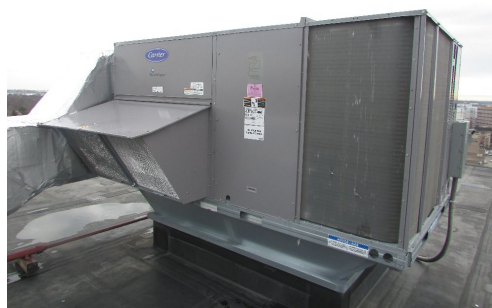
This line item is for the future replacment of the Roof Top Unit Air Handler. Services the common area/hallways.

1 - RTU	@\$80,000.00 =	\$80,000.00
1 - removal/install	@ 40,000.00 =	40,000.00
	Total =	\$120,000.00

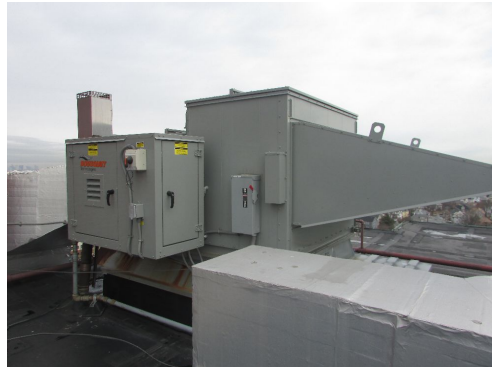
*Equipment - Air Handler, (RTU), Club continued...*

This line item is for the future replacment of the Roof Top Unit Air Handler. Services the club area.

1 - RTU	@\$40,000.00 =	\$40,000.00
1 - removal/install	@ 20,000.00 =	<u>20,000.00</u>
	Total =	\$60,000.00

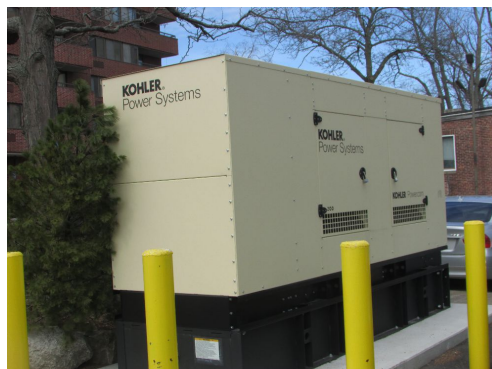
### Equipment - Back Up Generator - 2046

Asset ID	1182	1 Total	@ \$125,000.00
		Asset Cost	\$125,000.00
		Percent Replacement	100%
		Future Cost	\$213,360.81
Placed in Service	Equipment	Assigned Reserves	<i>none</i>
Useful Life	January 2016		
Replacement Year	30	Annual Assessment	\$3,367.33
Remaining Life	2046	Interest Contribution	<u>\$23.57</u>
	27	Reserve Allocation	\$3,390.90

1 - back up generator	@\$125,000.00 =	<u>\$125,000.00</u>
	Total =	\$125,000.00

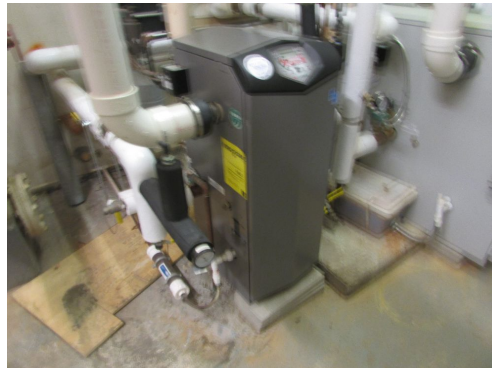
**Equipment - Boiler (Armor) - 2030**

Asset ID	1180	1 Total	@ \$56,000.00
		Asset Cost	\$56,000.00
		Percent Replacement	100%
		Future Cost	\$69,628.96
Placed in Service	Equipment	Assigned Reserves	<i>none</i>
Useful Life	January 2010		
Replacement Year	20	Annual Assessment	\$2,855.63
Remaining Life	2030	Interest Contribution	<u>\$19.99</u>
	11	Reserve Allocation	\$2,875.62

2 - boilers

@\$28,000.00 = \$56,000.00  
Total = \$56,000.00

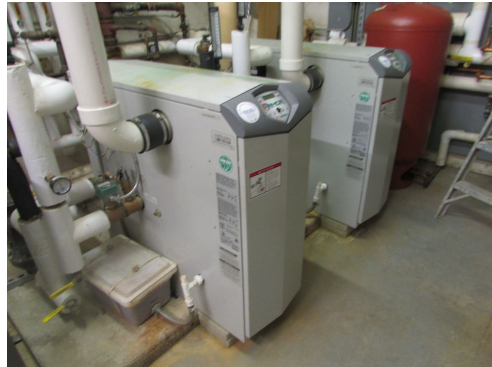
*Equipment - Boiler (Knight) continued...*

1 - boiler

@ \$28,000.00 = \$28,000.00  
 Total = \$28,000.00

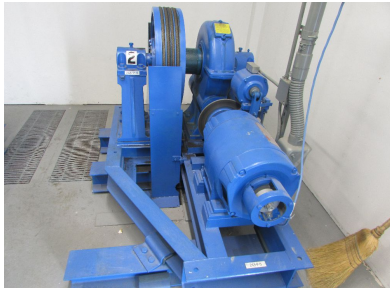
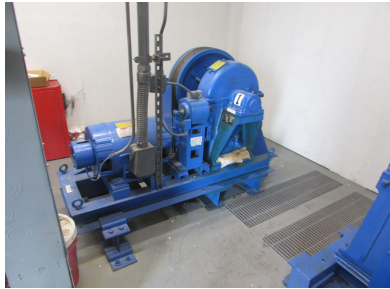
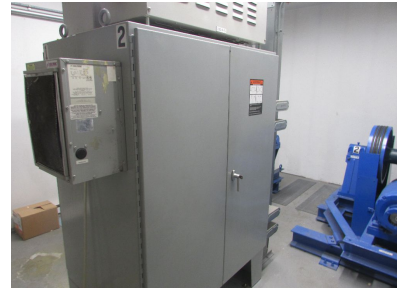
*Equipment - Elevators, Modernization continued...*

2 - elevators

@\$200,000.00 = \$400,000.00  
Total = \$400,000.00

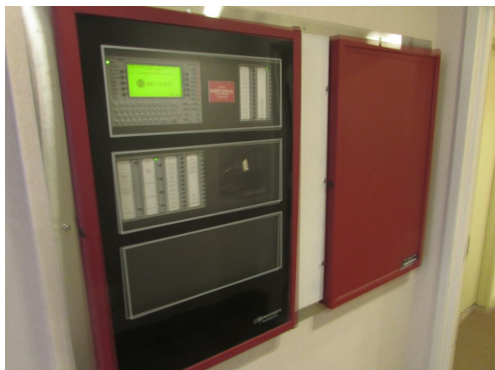
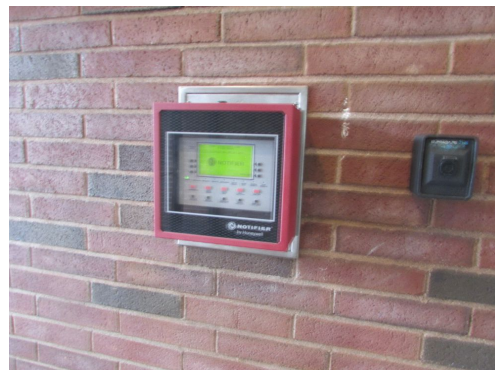
### Equipment - Fire Control Panel, Replacement - 2038

The estimated cost is for the replacement of the main fire control panel and software upgrade only. The estimated cost does not include any other part of the fire control system (pull stations, smoke detectors, emergency lights, valves, pumps, motors).

Fire control systems must always be kept in a good state of repair/working.

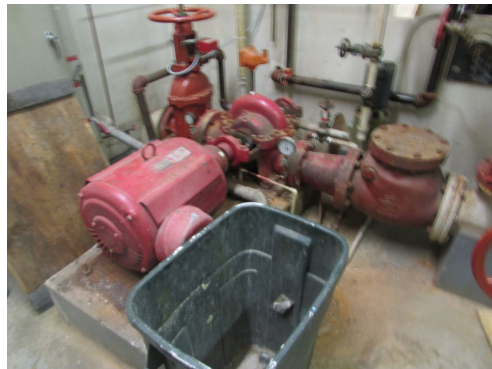
## **Equipment - Fire Pump - 2020**

Asset ID	1136	1 Total	@ \$30,000.00
		Asset Cost	\$30,000.00
		Percent Replacement	100%
	Equipment	Future Cost	\$30,600.00
Placed in Service	January 1982	Assigned Reserves	\$29,210.53
Useful Life	30		
Adjustment	8	Annual Assessment	\$553.70
Replacement Year	2020	Interest Contribution	<u>\$208.35</u>
Remaining Life	1	Reserve Allocation	\$762.05

1 - fire pump

@\$30,000.00 = \$30,000.00  
Total = \$30,000.00

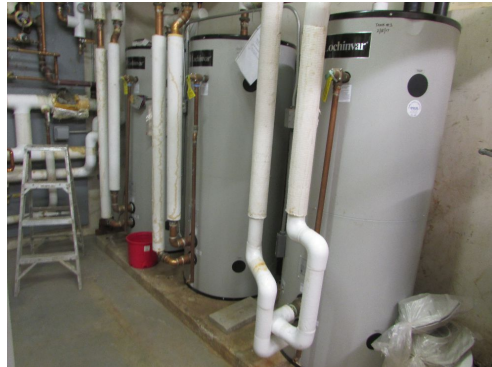
*Equipment - Hot Water Storage continued...*

3 - 300gal.

@\$22,000.00 = \$66,000.00  
Total = \$66,000.00

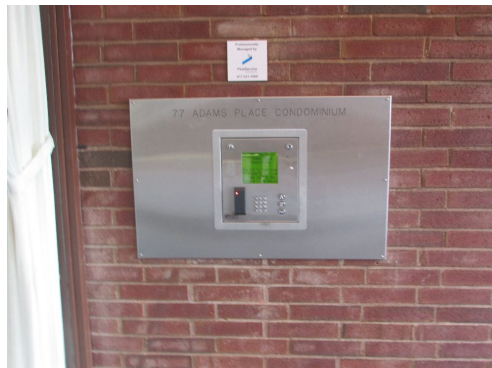
### Equipment - Keypad (Access) - 2021

Asset ID	1172	1 Total	@ \$4,200.00
		Asset Cost	\$4,200.00
		Percent Replacement	100%
		Future Cost	\$4,369.68
Placed in Service	Equipment	Assigned Reserves	<i>none</i>
Useful Life	January 1982		
Adjustment	20	Annual Assessment	\$1,017.33
Replacement Year	19	Interest Contribution	<u>\$7.12</u>
Remaining Life	2021	Reserve Allocation	\$1,024.45
	2

1 - access keypad

@\$4,200.00 = \$4,200.00  
Total = \$4,200.00

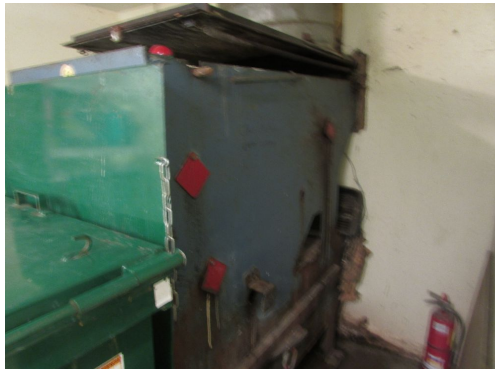
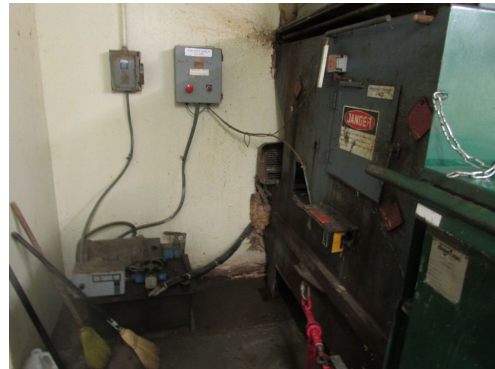
## **Equipment - Trash Compactor, Replacement - 2029**

Asset ID	1081	1 Total	@ \$26,000.00
		Asset Cost	\$26,000.00
		Percent Replacement	100%
		Future Cost	\$31,693.85
Placed in Service	Equipment	Assigned Reserves	<i>none</i>
Useful Life	January 1982		
Adjustment	30		
Replacement Year	17	Annual Assessment	\$1,434.87
Remaining Life	2029	Interest Contribution	<u>\$10.04</u>
	10	Reserve Allocation	\$1,444.92

1 - trash compactor

@\$26,000.00 = \$26,000.00  
Total = \$26,000.00

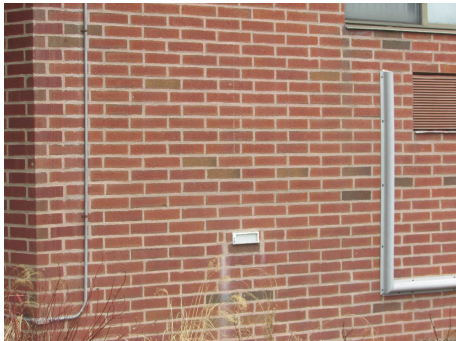
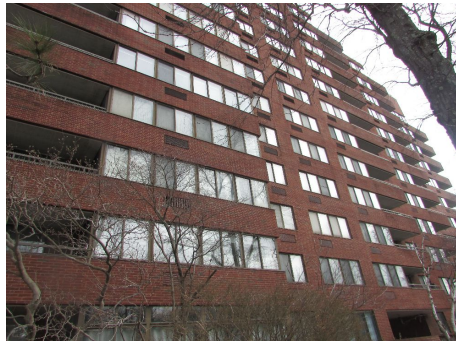
### Exterior - Brick/Masonry, Repairs - 2028

This line item is for the repairing of the brick/masonry/marble exterior areas. The total sq.ft. is for the entire bldg.. A percent of the total area has been used for funding purposes (10%). This percent can be and should be adjusted accordingly over time based on the actual history of needed maintenance (repairs).

The Useful Life is set at 10yrs. Maintenance (repairs) for brick/masonry/marble should be minimal during the first 30yrs.

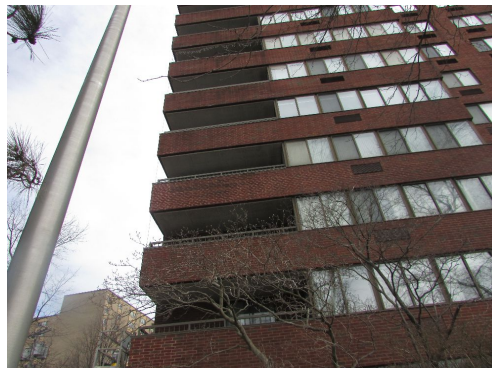
### Exterior - Deck Railing (metal) - 2022

1,350 - lin.ft. of metal railing @ \$58.00 = \$78,300.00  
Total = \$78,300.00

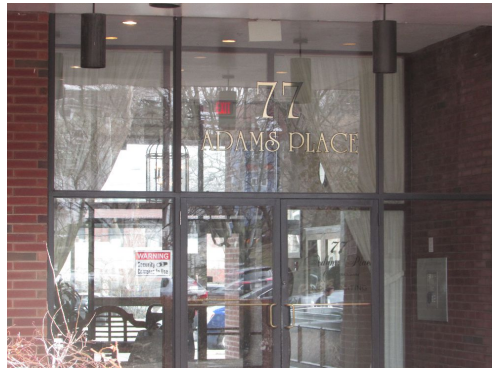
### Exterior - Entrance Doors - 2022

5 - metal/glass doors @ \$3,800.00 = \$19,000.00  
Total = \$19,000.00

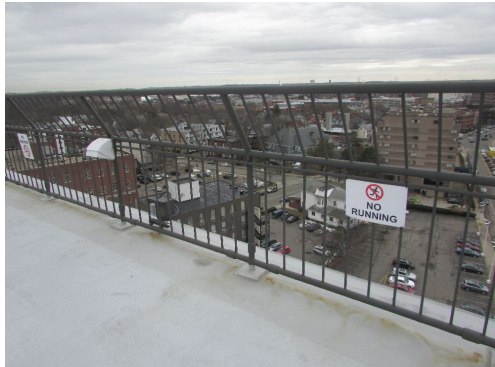
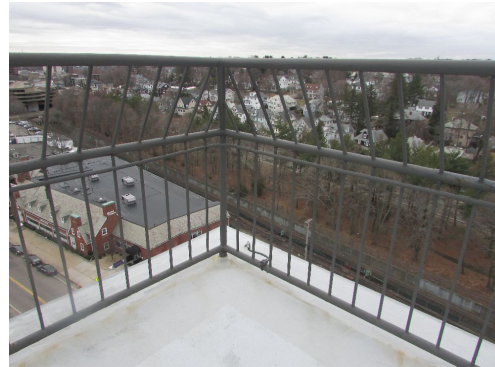
*Exterior - Pool Fencing (metal) continued...*

199 - lin.ft. of metal railing

@ \$68.00 = \$13,532.00  
Total = \$13,532.00

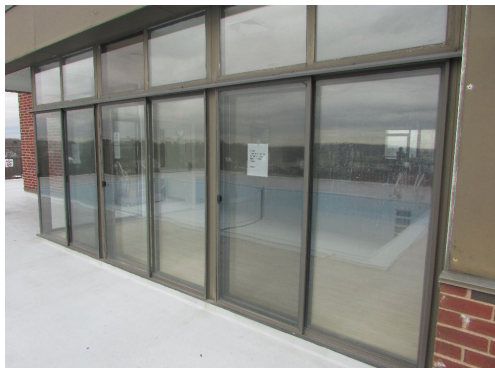
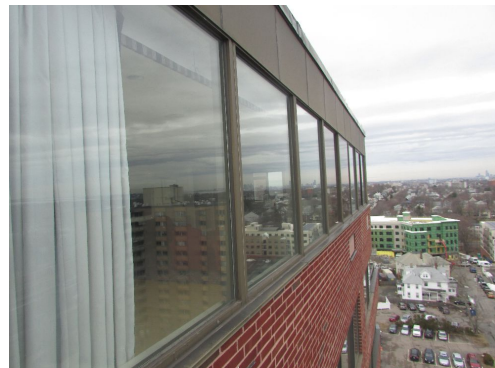
4 - sliders  
23 - picture windows

@ \$3,200.00 = \$12,800.00  
@ 3,800.00 = 87,400.00  
Total = \$100,200.00
