# Michael Callahan(RS) Associates, LLC.

Sample

AnyCity, AnyState  
Account Sample - Version 1  
January 1, 2019

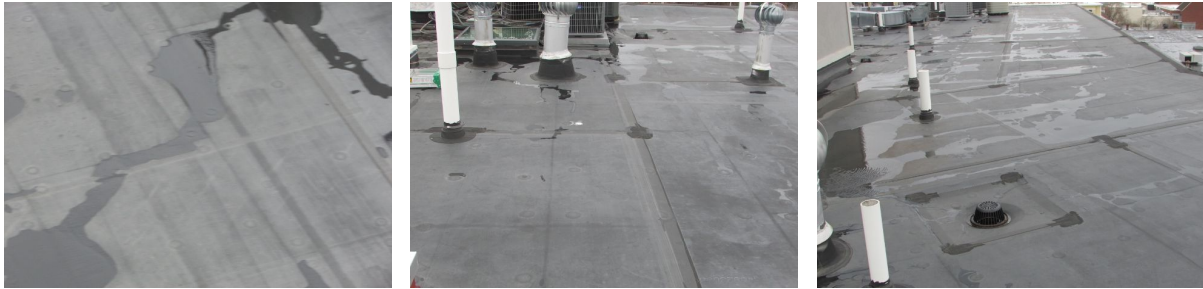
*Roof - Flat, Membrane, Mid-Rise #1 continued...*

4,588 - sq.ft. of rubber membrane roofing (2 Chestnut) @ \$22.00 = \$100,936.00  
Total = \$100,936.00

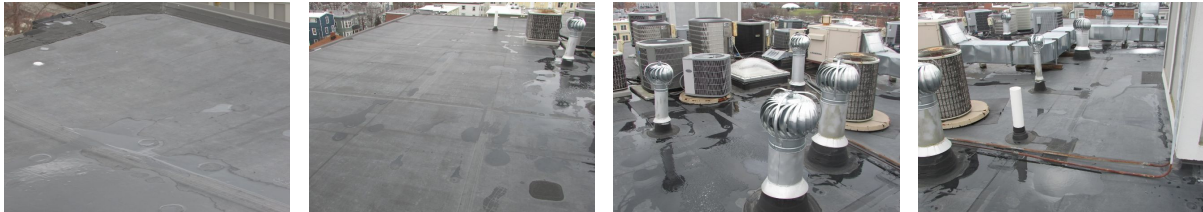
## *Roof - Flat, Membrane, Mid-Rise #2 continued...*

8,928 - sq.ft. of rubber membrane roofing (20 Chestnut) @ \$22.00 = \$196,416.00  
Total = \$196,416.00

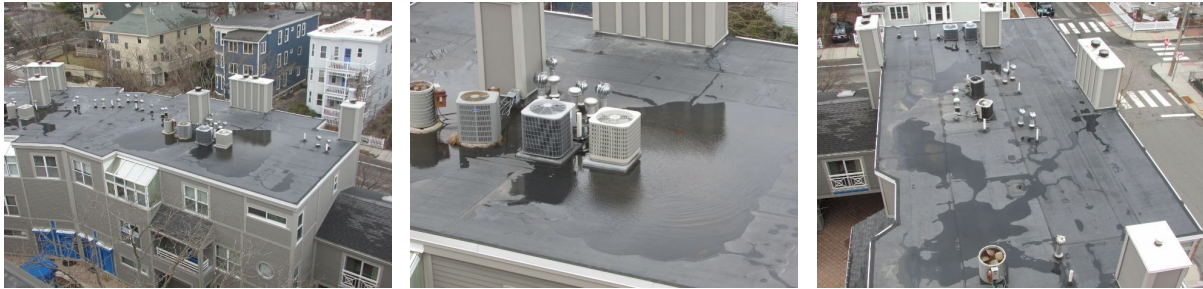
*Roof - Flat, Membrane, Townhouse #1-#3 continued...*

8,884 - sq.ft. of rubber membrane	@	\$22.00 =	\$195,448.00
		Total =	\$195448.00

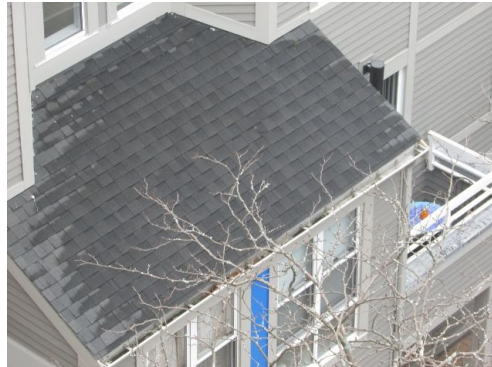
*Roofs - Asphalt Shingle, Low-Rise #1 & #2 continued...*

The estimated cost used is for a quality 25-30 year rated asphalt composition shingle, all new underlayment, flashing and drip edge. A provision should be included in any work contract for the replacement of sheathing. Most likely some of the sheathing will require replacement. However, until the roofing system is removed from the roof deck it is next to impossible to know how much if any of the sheathing will require replacement.

1,200 - sq.ft. of asphalt roofing	@	8.00 =	9,600.00
		Total =	\$9,600.00

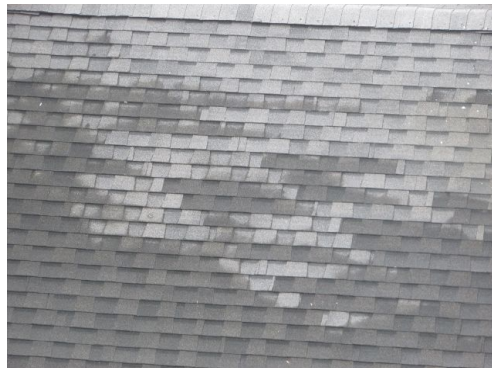
1,600 - sq.ft. of asphalt roofing	@	\$8.00 =	<u>\$12,800.00</u>
		Total =	\$12,800.00

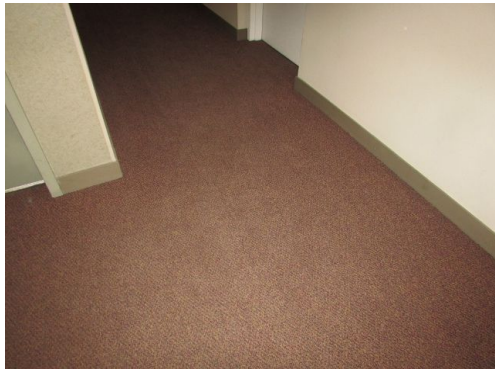
183 - sq.yds. of carpet

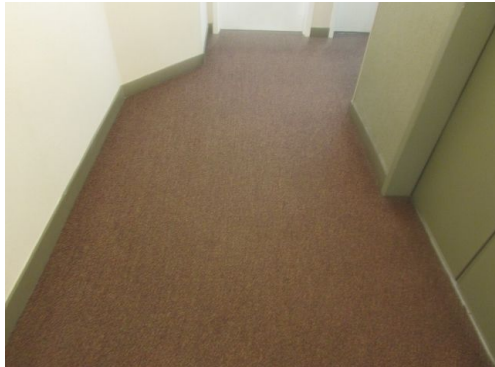
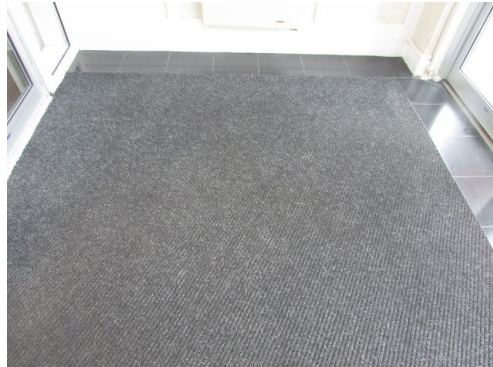
*Building - Carpet, Bldg. Mid-Rise #2 continued...*

528 - sq.yds. of carpet

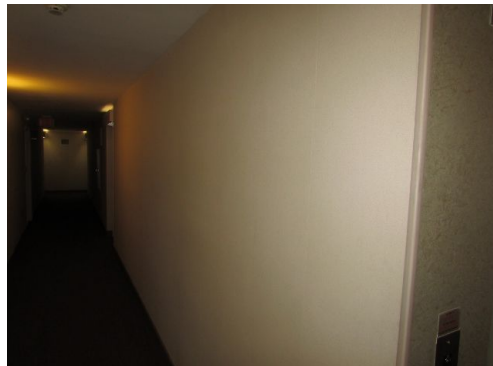
5,604 - sq.ft. of wallpaper

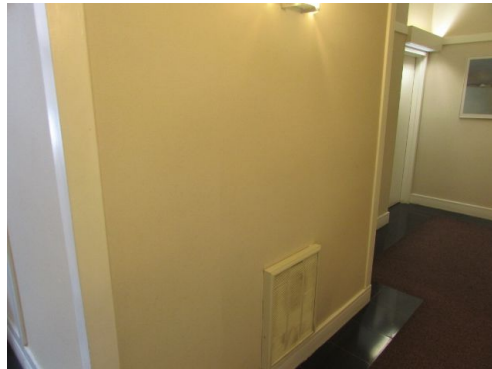
14,256 - sq.ft. of wallpaper @ \$5.75 = \$81,972.00  
Total = \$81,972.00

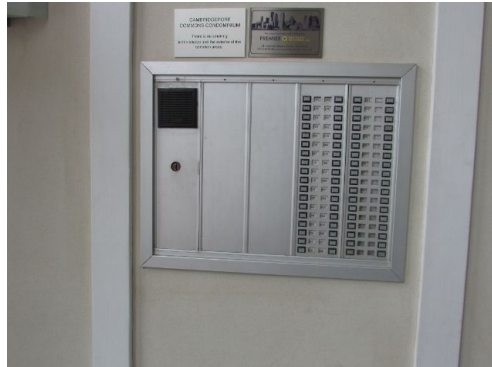
*Access Keypad - Bldg. Mid-Rise #2 continued...*

1 - access keypad	@	\$4,800.00 =	<u>\$4,800.00</u>
		Total =	\$4,800.00

This line item is for the replacement of the main entrance access keypad only. It does not include any other part of the intercom/access system.

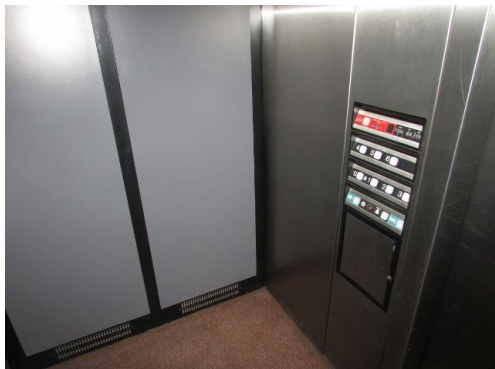
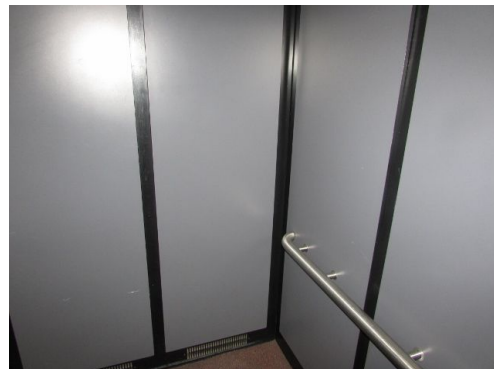
1 - cab	@	\$6,200.00 =	<u>\$6,200.00</u>
		Total =	\$6,200.00

This line item is for the refurbishment of the elevator cabs. It would include the cosmetic

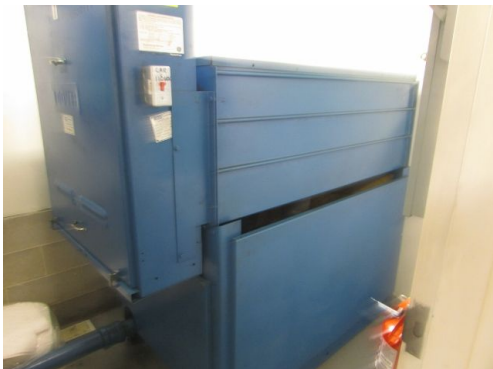
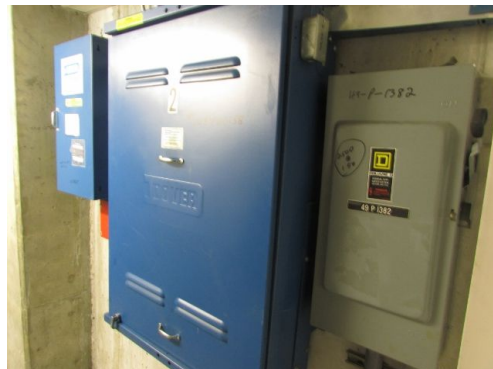
1 - elevator

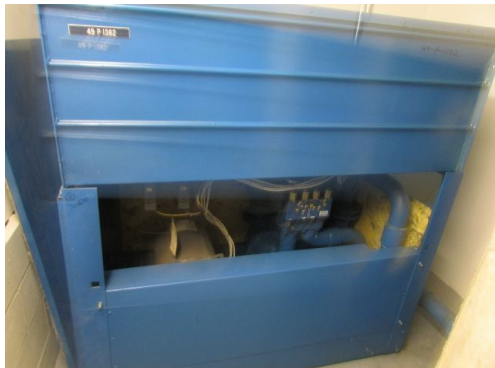
2 - elevators

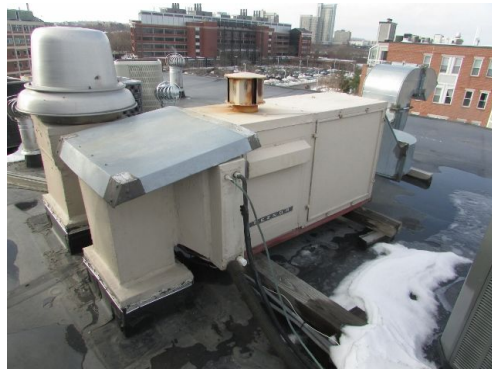
1 - air handler	@ \$60,000.00 =	\$60,000.00
1 - removal/install	@ 20,000.00 =	<u>20,000.00</u>
	Total =	\$80,000.00

An air handler, is a device used to condition and circulate air as part of a heating, ventilating, and air-conditioning system. Usually, an air handler is a large metal box containing a blower, heating and/or cooling elements, filter racks or chambers, sound attenuators, and dampers. Air handlers usually connect to ductwork that distributes the conditioned air through the building, and returns it to the AHU. Sometimes AHUs discharge (supply) and admit (return) air directly to and from the space served, without ductwork.

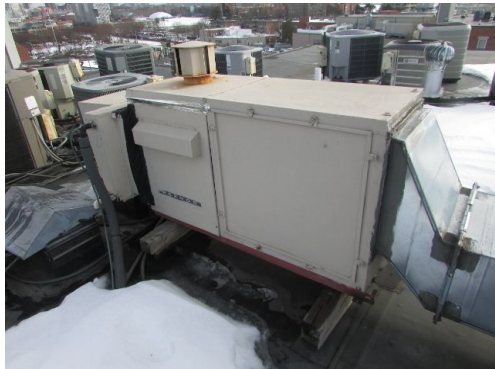
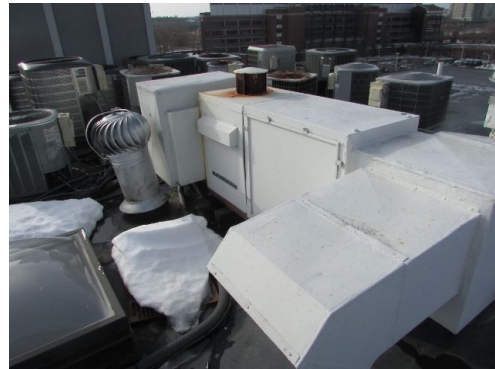
2 - air handler  
2 - removal/install

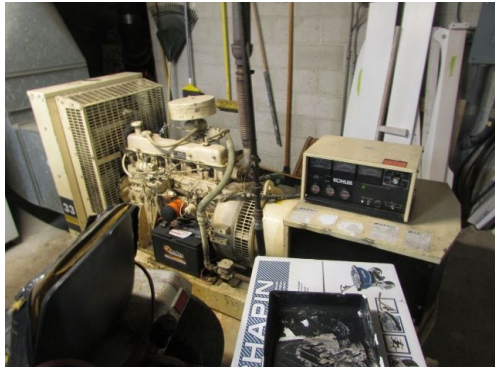
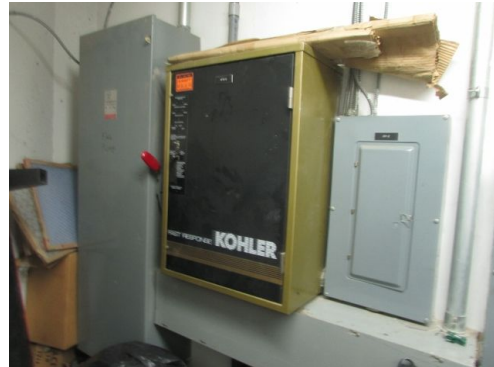
## *Equipment - Back-Up Generator continued...*

1 - generator	@\$60,000.00 =	\$60,000.00
1 - removal/install	@ 6,000.00 =	<u>6,000.00</u>
	Total =	\$66,000.00

The back up generator is on a start up/maintenance program. The back up generator will run for a short period of time in order to keep the moving parts well lubed. This start up maintenance will also indicate any other issues or needed PM servicing to the back up generator.

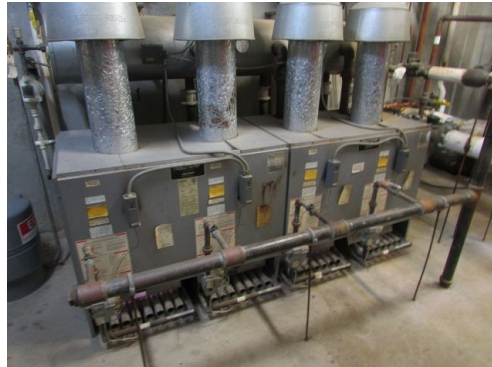
*Equipment - Boiler, Replacements continued...*

The actual cost to replace these boilers will include a lot of demo, re-building, new plumbing and wiring in order to accomodate the new updated boiler system.

This line item is an estimate for the future replacement of the boilers only.

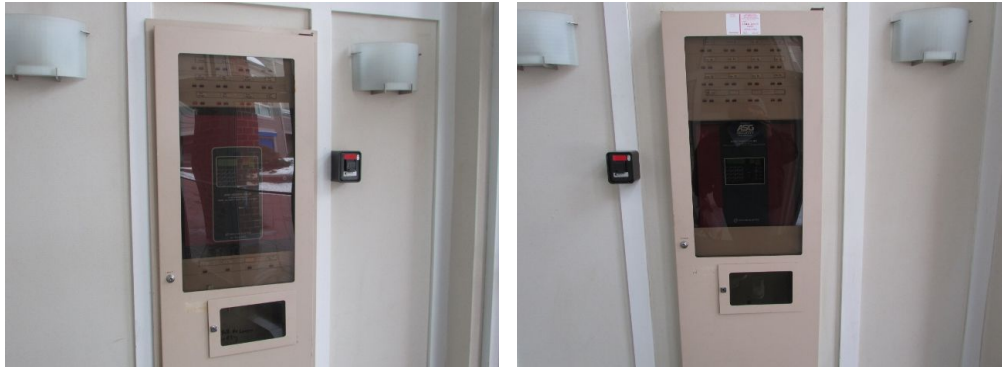
## *Equipment - Fire Control Panel, Replacements continued...*

The estimated cost is for the replacement of the main fire control panel and software upgrade only. The estimated cost does not include any other part of the fire control system (pull stations, smoke detectors, emergency lights, valves, pumps, motors).

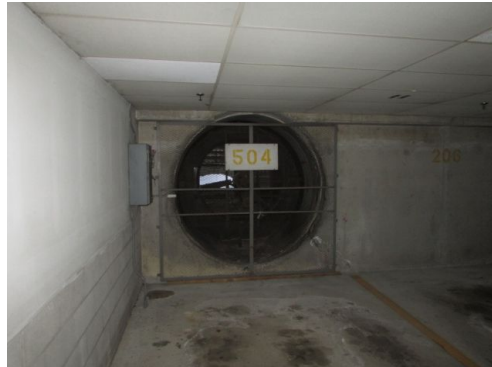
*Equipment - Garage, Exhaust Fan continued...*

1 - exhaust fan	@ \$8,000.00 =	\$8,000.00
	Total =	\$8,000.00

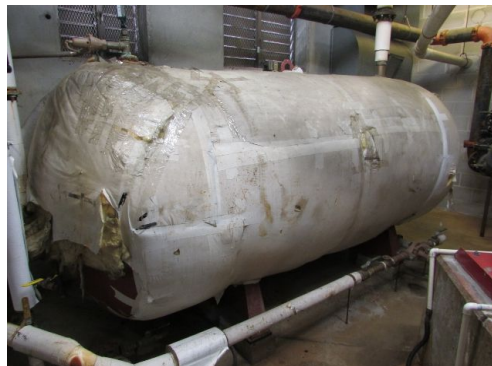
There is really no actual maintenance to the actual storage tank. Check sealed areas, supply and distribution pipes that are threaded into the storage tank for leaks. Any noted leaks should be addressed immediately. The bladder and actual tank wall thickness should be tested in order to make sure both are properly working and safe against possible leaking, cracking and major failures.

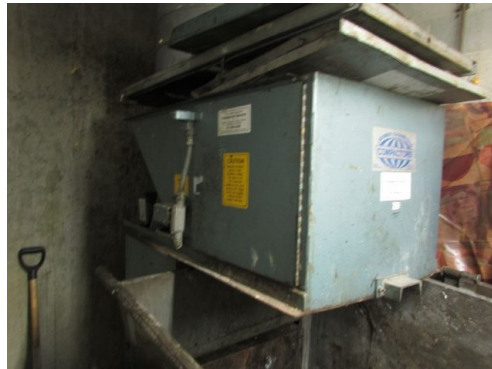
1 - trash compactor	@ \$12,000.00 =	\$12,000.00
1 - removal/install	@ 2,000.00 =	<u>2,000.00</u>
	Total =	\$14,000.00

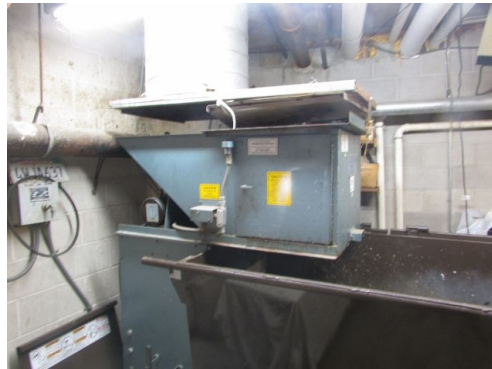
1 - trash compactor	@ \$12,000.00 =	\$12,000.00
1 - removal/install	@ 2,000.00 =	<u>2,000.00</u>
	Total =	\$14,000.00

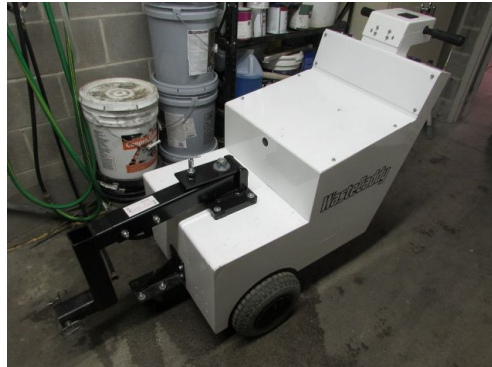
*Equipment - Waste Caddy continued...*

Rountine PM - Make sure the battery pack is not leaking. Check battery connections for corrosion, clean if needed. Check wheel bearings for dirt, properly greased. Check controls to make sure all connections and functions are working properly.

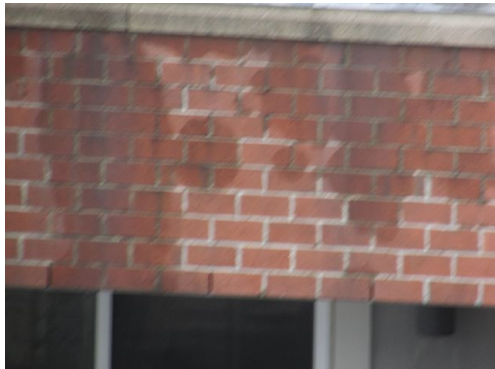
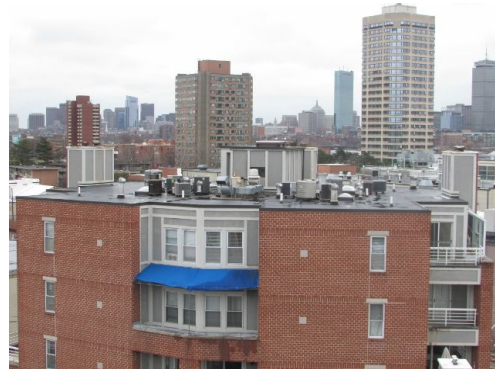
56,928 - sq.ft. of brick surface @ \$32.00 = \$1,821,696.00  
Total = \$1,821,696.00

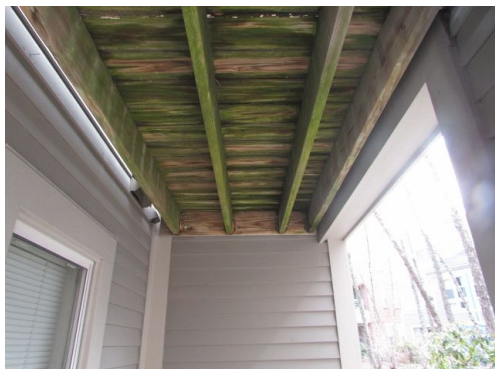
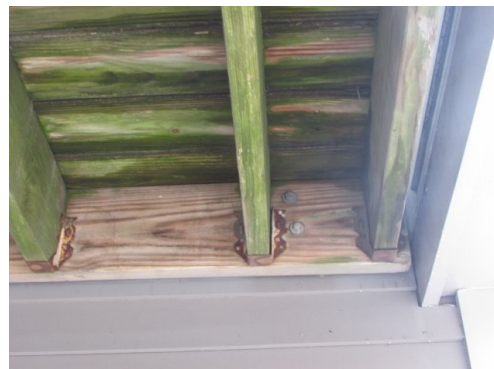
8 - wood decks

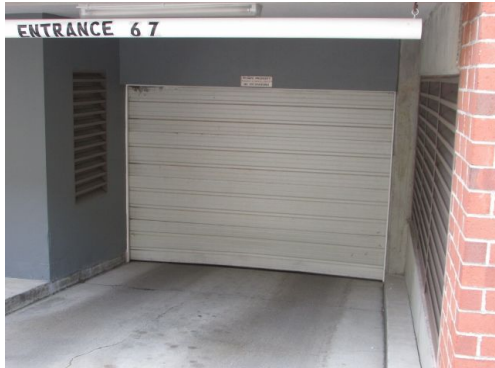
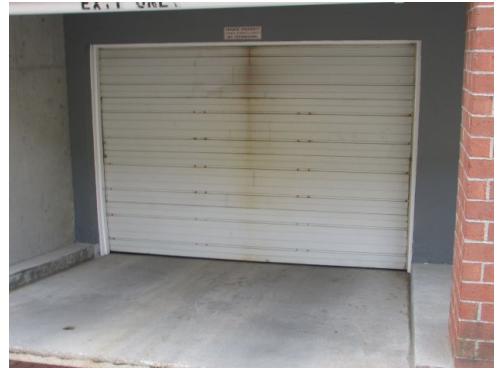
2 - roll up garage doors

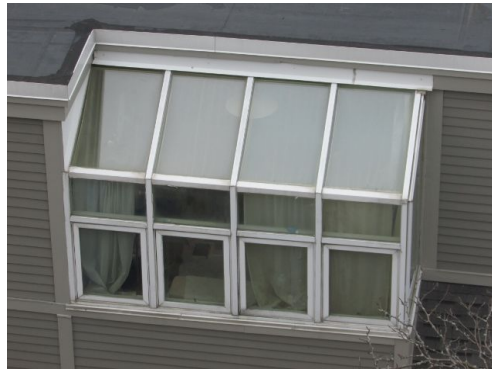
8 - green house

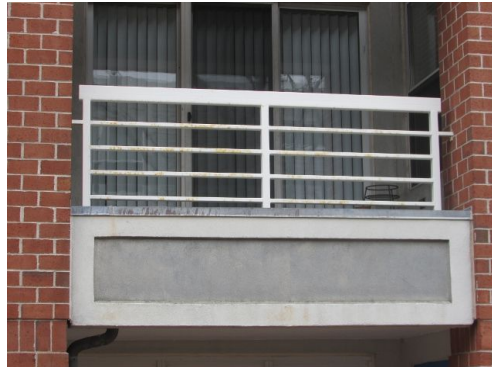
## *Metal Railing - Replacements, All Bldgs. continued...*

702 - lin.ft. of metal railing @ \$62.00 = \$43,524.00  
Total = \$43,524.00

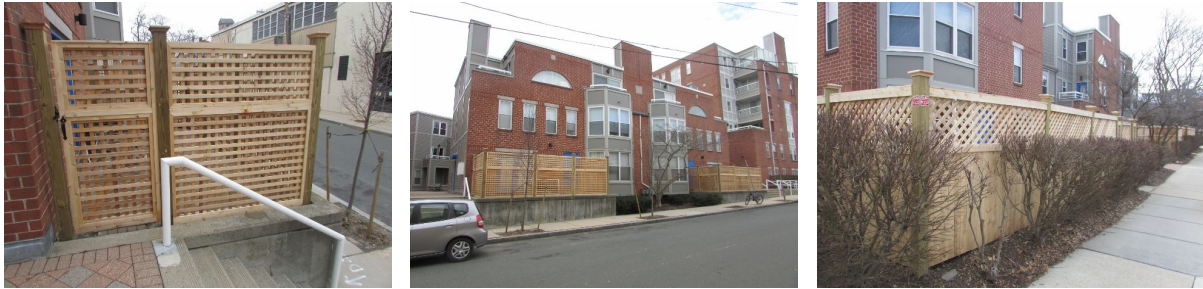
### *Patio Fence - Replacements (Wood) continued...*

The new patio fencing should be aged for one year before protecting it with a stain. Then the patio fencing should be put on a set schedule for staining in order to protect the wood from the elements. Staining is not considered a reserve funding expense. The staining should be funded for through the annual operational budget and/or a paint/stain fund.

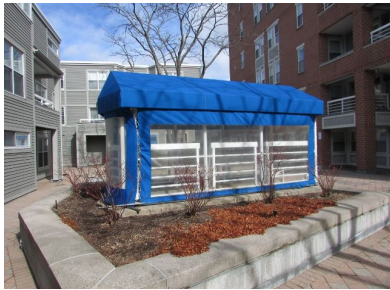
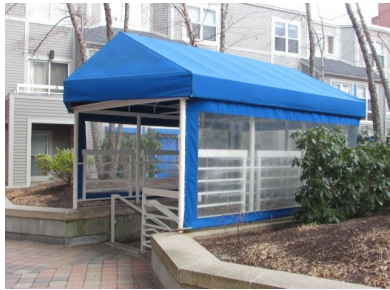
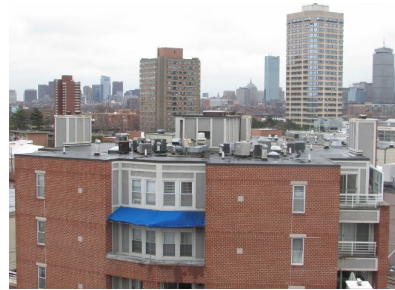
3 - awings
