High Rise Sample II

AnyCity, AnyState Account Sample - Version 1 January 1, 2019

Current Assessment Funding Model Summary (Cash Flow)	2-1
Current Assessment Funding Model Projection	2-2
Current Assessment Funding Model VS Fully Funded Chart	2-3
Current Assessment Annual Expenditure Chart	2-4
Current Assessment Spread Sheet	2-5
Distribution of Accumulated Reserves	2-9

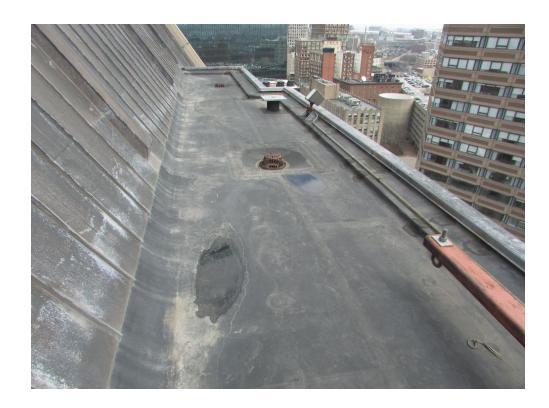
6,758 - sq.ft. of rubber membrane roofing (a) 32.00 = 216,256.00Total = 216,256.00

Typically, flat rubber membrane roofs come with a 20yr. Limited Warranty.

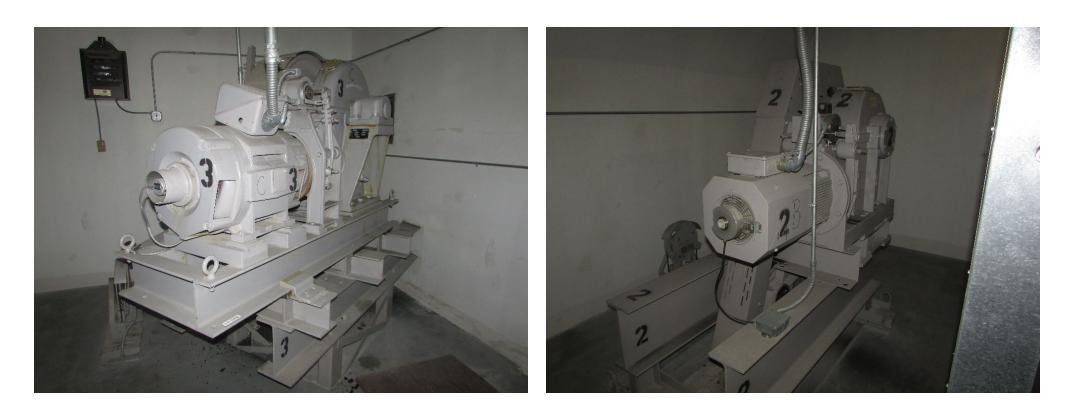
Elevators - Drives, Elevator #1 continued...

Elevator #1 has a new Drive is a Yaskawa 91A 460v Q Rise 1000A installed in February, 2017. At the time of replacement of this Drive the cost was \$30K. The Allen Bradley Drives are no longer been manufacture for this application.

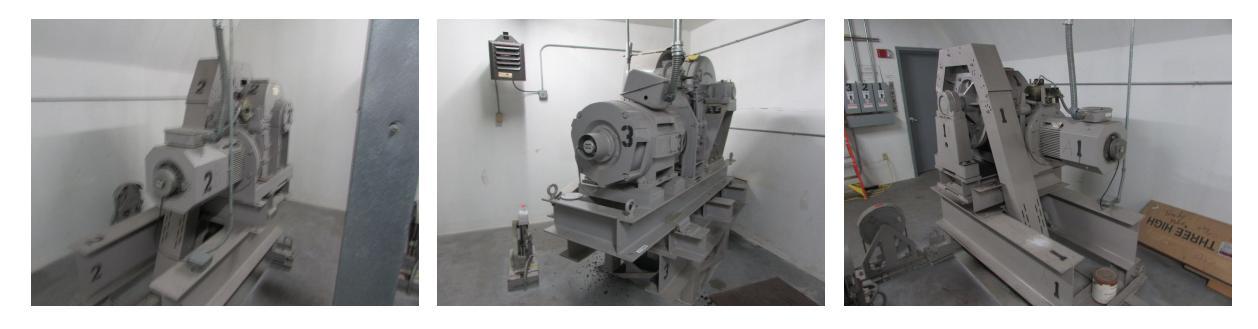
Elevator #2 has an Allen Bradley 1336M Drive replaced in 2006.

Elevators #2 and #3 cost to replace Drives were a 3rd of elevator #1 because, of the Allen Bradley Drive been an exact replacement of the original Drive.

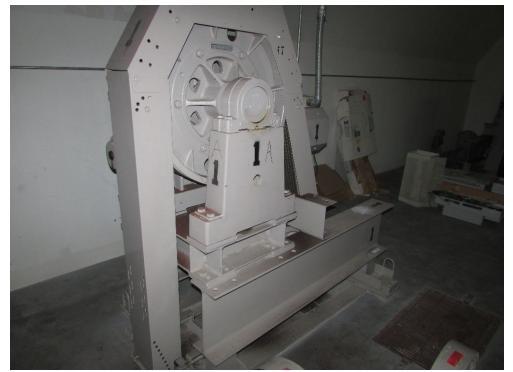
Elevator #3 has an Allen Bradley 1336M Drive replaced in 2011.

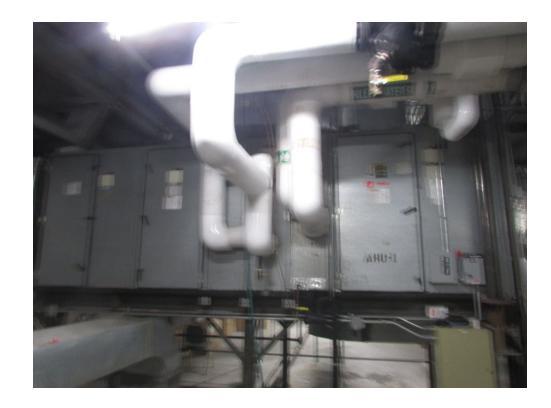
- air handler	@\$80,000.00 =	\$80,000.00
- removal/install	@ 40,000.00 =	40,000.00
	Total =	\$120,000.00

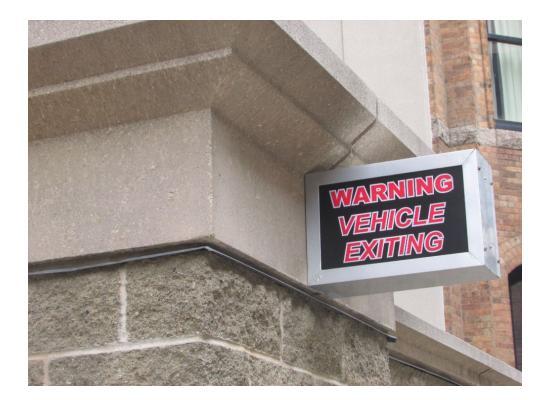
Equipment - Auto Court Safety System continued...

This line item is for the replacement of the alarm system for cars leaving the courtyard drive area.

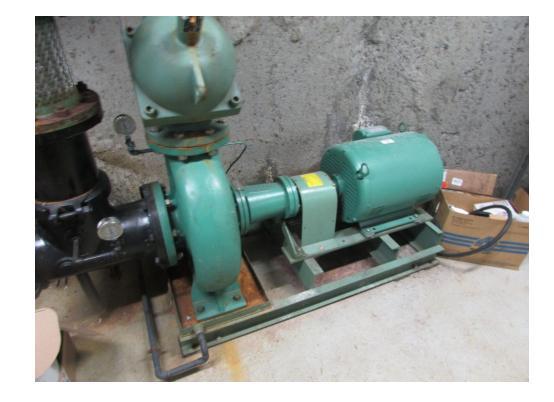
This booster pumps system raises the water pressure in order to properly deliver water to all of the units throughout the bldg.

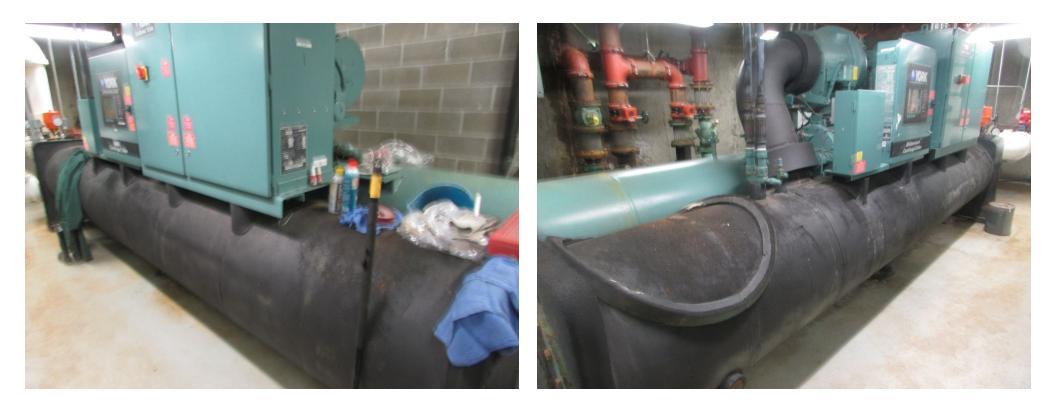
2 - chillers2 - removal/install

@\$380,000.00 =\$760,000.00 @ 40,000.00 = 80,000.00 Total = \$840,000.00

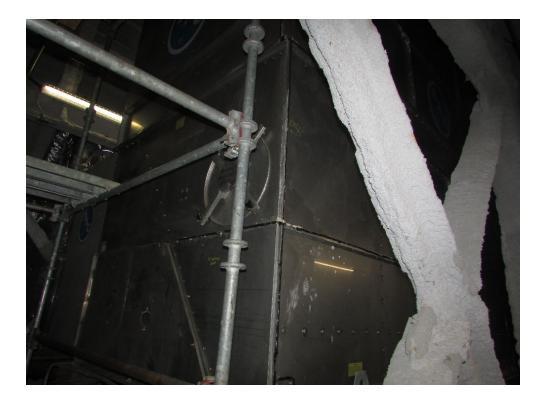
cooling tower
 removal/install

@\$200,000.00 =\$200,000.00 @100,000.00 = 100,000.00 Total = \$300,000.00

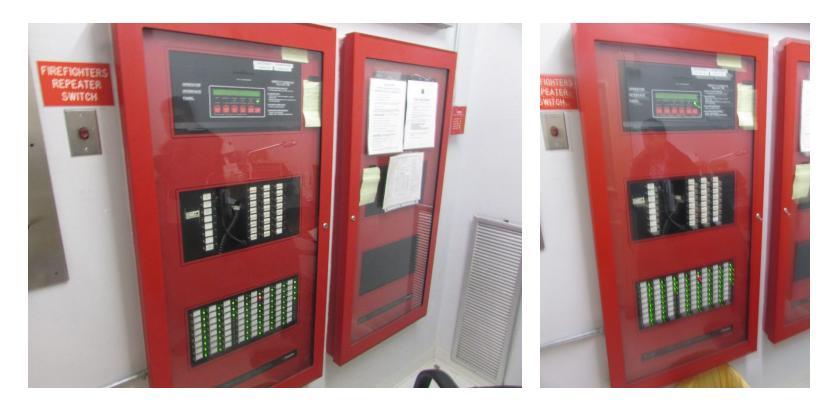
The estimated cost is for the replacement of the main fire control panel, sub-panels, and software upgrade only. The estimated cost does not include any other part of the fire control system (pull stations, smoke detectors, emergency lights, valves, pumps, motors).

Fire control systems must always be kept in a good state of repair/working.

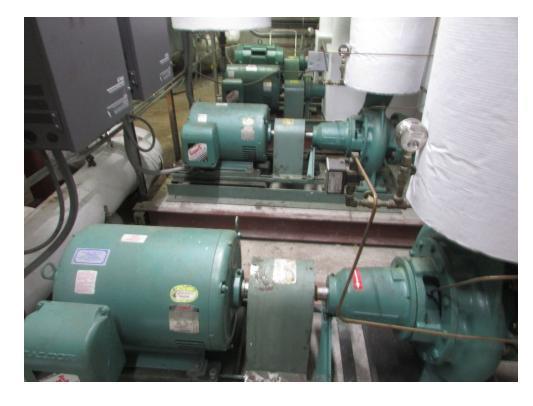
2 - 5hp pump motor (ground water run off) @ \$4,800.00 = ____\$9,600.00

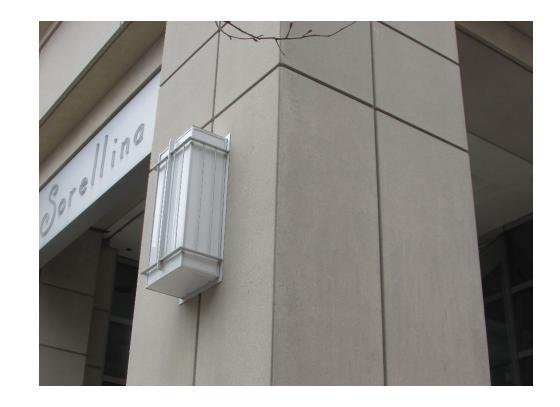
This line item is for exterior caulking. Properly applied caulking keeps window, doors, sliding glass doors, building joints, and transition areas air/water tight. Typically, exterior caulking will last 6-10yrs depending on the quality of the caulking.

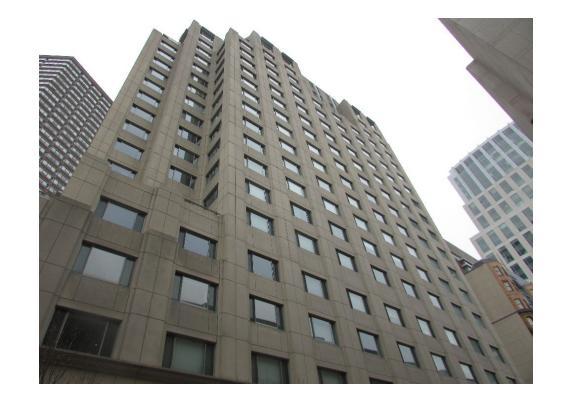
This line item is set up to help address any unforeseen issues with the concrete exterior. Needed maintenance (repairs and/or area replacements) should be minimal for the first 20-30yrs.

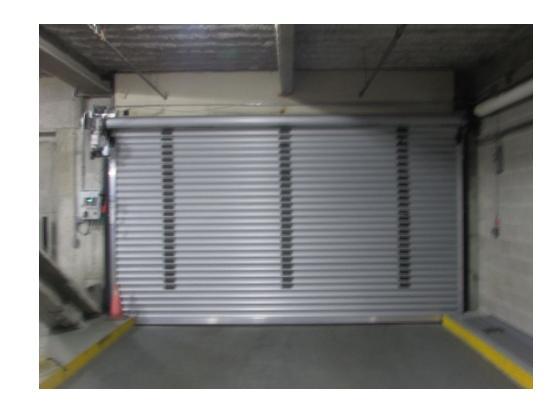
Rountine PM - make sure the doors move up and down freely. The tracks are balanced and not damaged. The motor is clean and clear of debris and build up that could cause it to run hot. Make sure the drive chain is not worn out, well lubricated, no kinks and track properly.
