Michael Callahan(RS) Associates, LLC.

Townhouse Sample

AnyCity, AnyState Account Smaple - Version 1 January 1, 2019

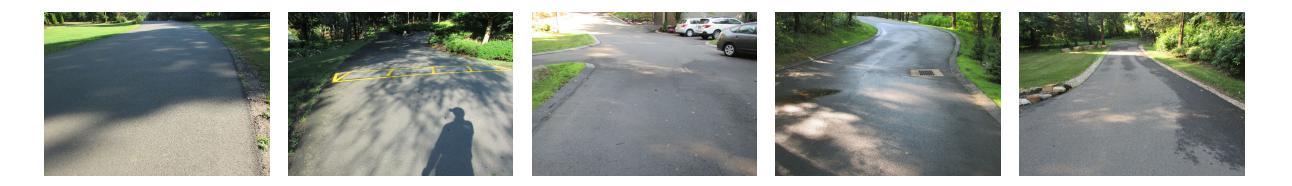
Asphalt Overlay - PUD Area, Replacement continued...

The total area includes the main drives, parking areas, and all of the driveway areas.

A good maintenance cycle along with 'as-needed' repairs and/or replacement to the asphalt overlay will help the overlay to last the estimated 20-30 year Useful Life. In most cases repairs and/or replacements to areas of the asphalt overlay will not increase the overall Useful Life of the asphalt overlay.

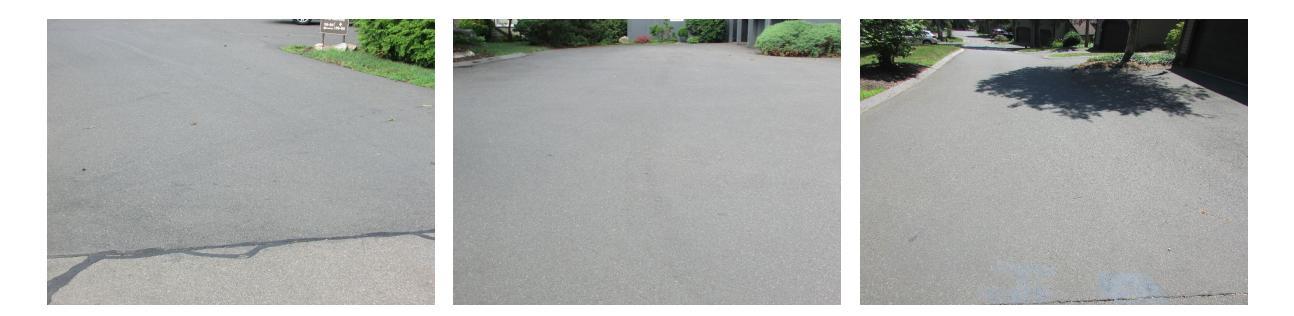
Asphalt Overlay - The Barns Area, Entrance Road Replacement continued...

This line item is for the entrance roadway to the Barns area from the Pillars to the mailbox area.

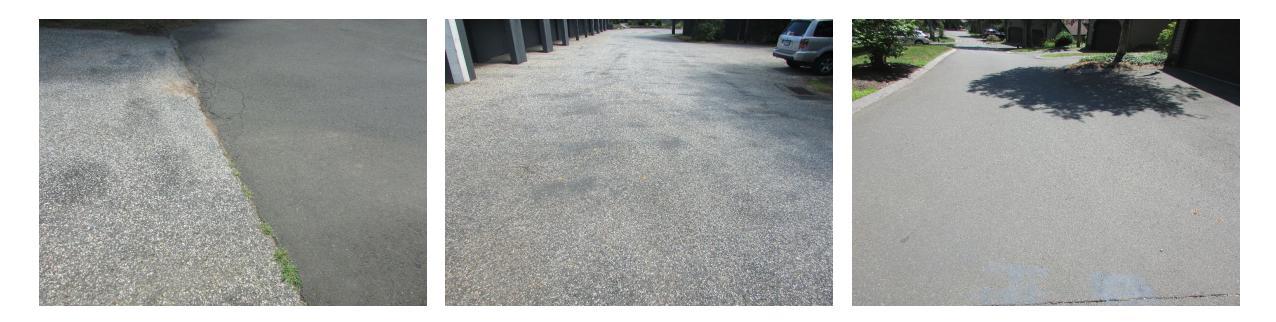
The total area includes the main drives, parking areas, and all of the driveway areas.

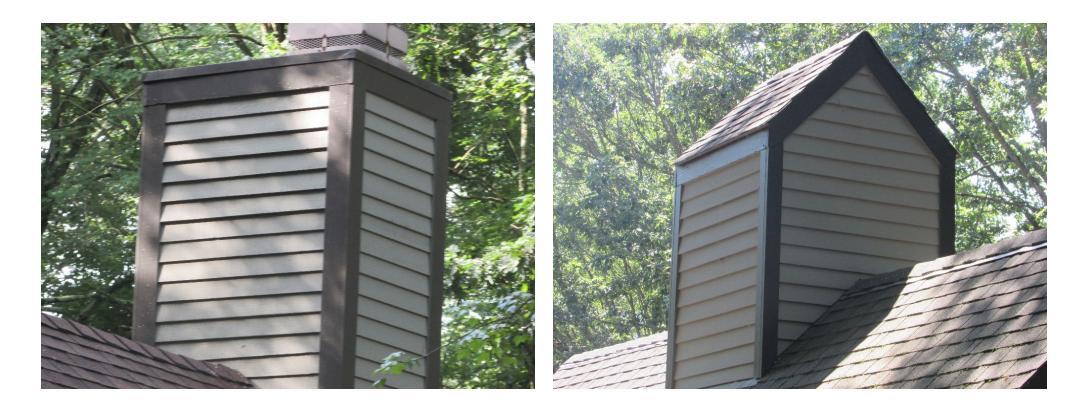
This line item is set up as an annual expense to address any 'as-needed' repairs and/or replacements of chimney caps or cupolas.

The maintenance/PM to the chimney cap would be to keep it protected. The easiest form of protection is to paint the the actual metal chimney cap.

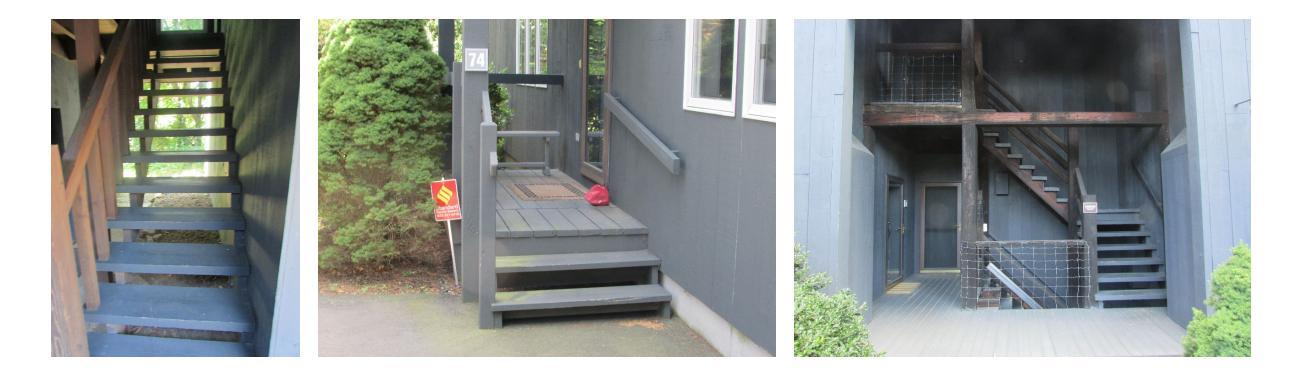
Deck, Stairway, & Landing - (The Barns), Schedule #1 continued...

This line item is set up to address the needed replacement of the decks, stairways, and landing areas located in The Barns area of the property. This includes both the multi-unit buildings as well as the individual homes.

The replacement schedule as been set up over a four year period of time.

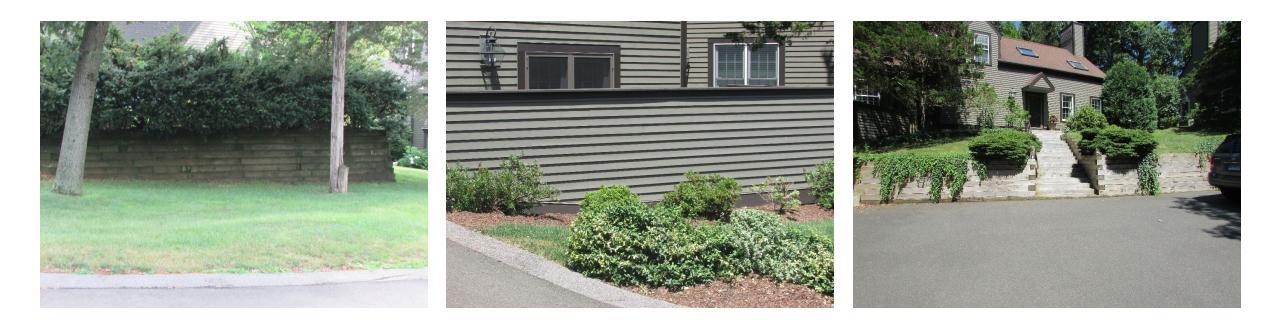
Typically, these types of components are repaired and/or replaced (areas) on an 'as-needed' basis. The set up is based on a set dollar amount to address needed repairs and/or replacements (area). The set dollar amount should be adjusted accordingly over time based on actual expenses in order to maintain gates, fencing, and Association retaining wall in a safe, good state of repair.

Retaining Wall Maintenance: A wood retaining wall can add both function and beauty to your landscape. Wood is a durable building material that is very easy to work with.

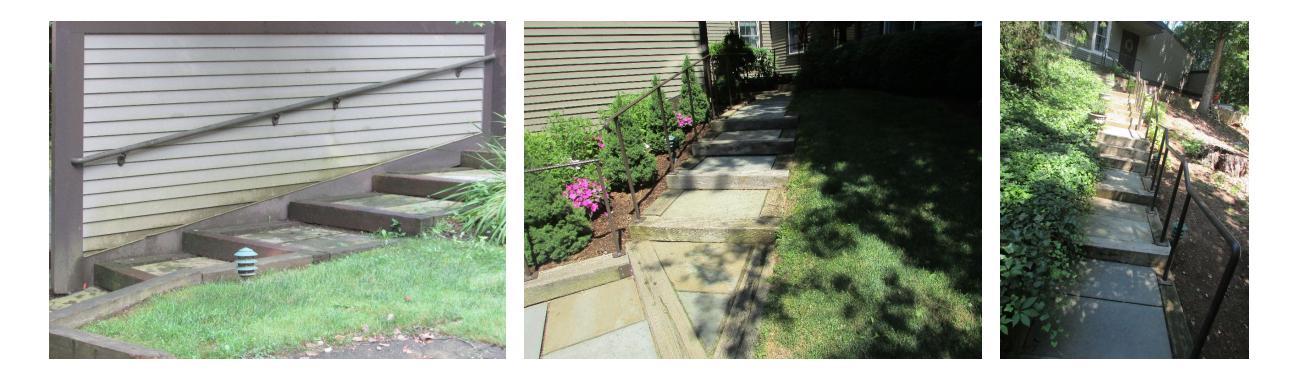
Walkway, Patio, & Terrace - Repairs & Replacements continued...

According to the client the Association is only responsible for a portion of the walkways, patios, and terrace areas.

This line item is set up in order to address needed repairs and/or replacements to these areas.

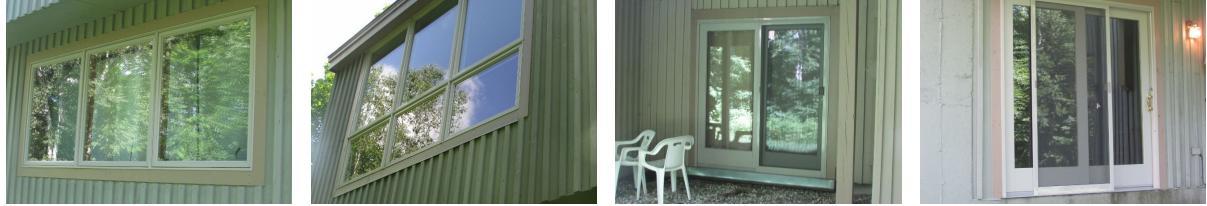
This line item is for the actual replacement of windows and exterior doors.

The set dollar amount is based on the estimated cost supplied to MCA by the client.

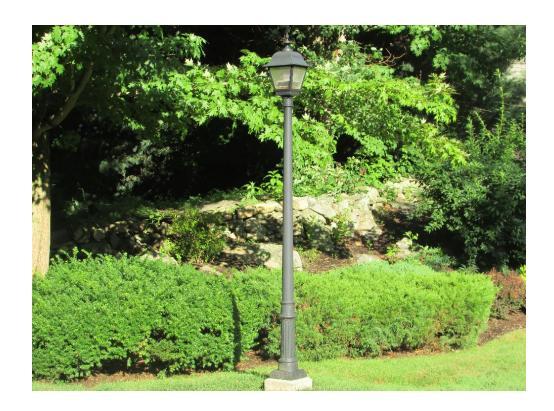
This line item is for the complete replacement of the light pole, light fixture, and re-wiring.

39 - light poles w/fixture
